# Research on Structural Health Monitoring of Steel Tower Structure Using Long-term Vibration Sensing

**Abstract** - Many steel tower structures built in Japan are aging and are increasingly at risk of collapse in the event of typhoons or major earthquakes. At the same time, it is difficult to proceed with rebuilding such aging structures with limited budgets and manpower, thus there is a need to monitor the health of the structures, and to equalize and facilitate the rebuilding work. For this purpose, it is necessary to make full use of sensing technology to diagnose deterioration in order to accurately assess the condition of steel tower structures. In this study, sensors were installed at multiple locations on an actual steel tower structure, and measurements were taken over a period of nine months. Data was measured and saved for five minutes, centered on the time when the maximum Root Mean Square (RMS) value of acceleration occurred each day. There have been no other studies in which measurements were taken and analyzed at the time when the maximum vibration occurred each day, with almost no missing data, over several months of constant measurement. This study aims to obtain

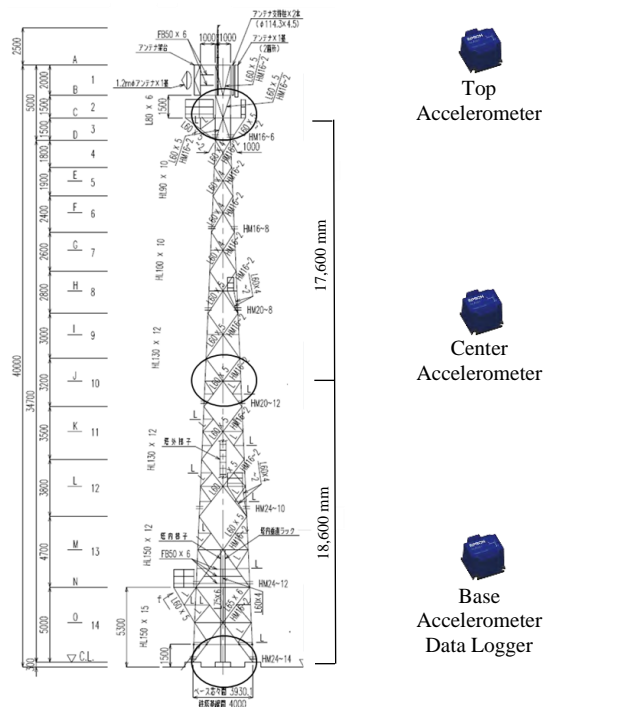
Figure 1. Steel tower structure and sensor location.

maximum RMS value of acceleration occurred on each day. Each sensor module had a built-in battery and wireless communication function that used the 2.4 GHz frequency band, and transmitted data wirelessly to a data logger for data recording, which was installed at the base shown in Figure 1. The batteries installed in each sensor module can power the system for approximately one year without needing to be replaced. Each sensor module stores data in its memory and transmits the data wirelessly to the logger. The logger was installed in a small temporary structure adjacent to the base of the tower structure and provided with Internet access, allowing data to be collected remotely.

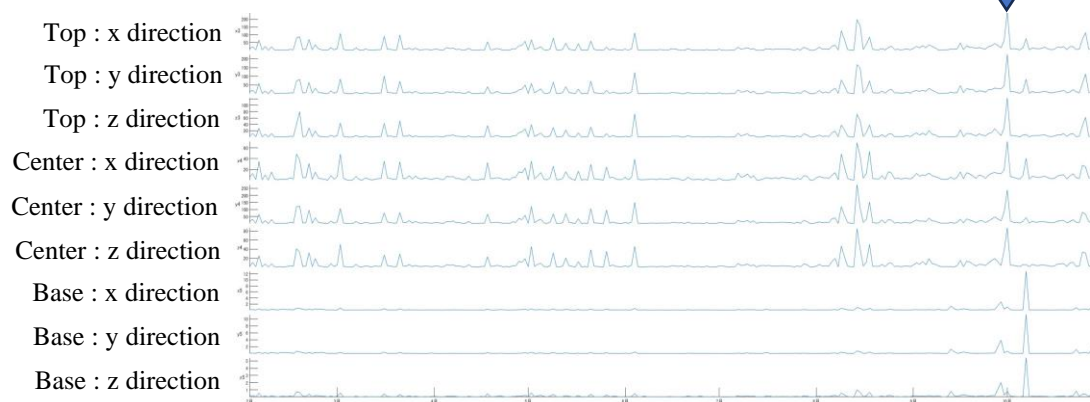
Figure 2. Maximum values measured by accelerometers during the measurement period.

Figure 2 shows the maximum values measured by accelerometers during the measurement period.

The day when the maximum acceleration occurred is indicated by ▼ in Figure 2. Figure 5 shows the time history waveforms of the data measured at the top of the tower by the accelerometer at this time. From Figure 5, it can be seen that at the top of the tower, accelerations of similar magnitude occur in the x and y-directions, which are horizontal directions, while almost no acceleration occurs in the z-direction, which is the vertical direction. As indicated in (2) above, the natural frequency in the x-direction can be observed at 1.66 Hz, and from (b), the horizontal natural frequency in the y-direction, at 1.59 Hz. In general, there is little structural difference between steel towers in the x- and y-directions, thus the natural frequencies are also close.

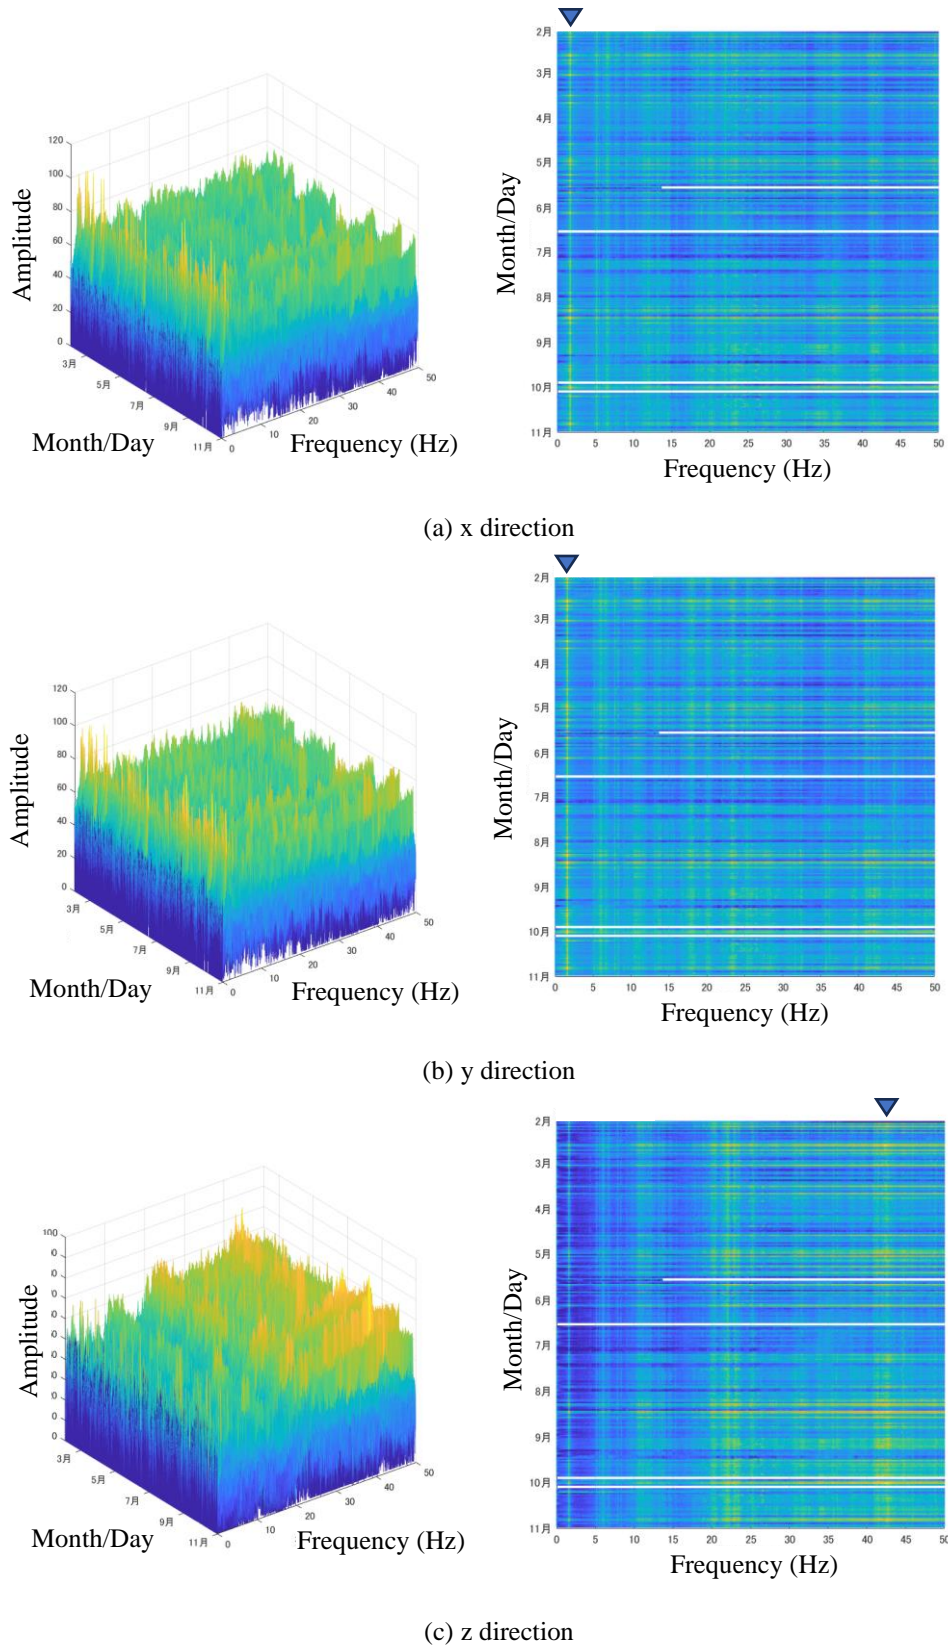
Figure 3. Fourier spectra of measured data at the top of the tower obtained by accelerometer during the measurement period.

Figure 3 shows the Fourier spectra of the measured data at the top of the tower obtained by an accelerometer during the measurement period. In Figures. 3(a) to (c), the diagrams on the left show the 3D Fourier spectrum with the date and frequency during the nine-month measurement period on the horizontal axis and amplitude plotted on the vertical axis; the diagrams on the right show this spectrum viewed from directly above, with the date and frequency on the axis and the amplitude in color. The white areas in the right diagrams are areas of missing data. The diagrams on the left give an overview of which frequencies were predominant with respect to acceleration at the top of the tower during the nine-month period, and whether these frequencies changed or not. From the diagrams on the right, the predominant frequencies and their changes can be clearly observed. Since this is the acceleration at the top of the tower, the first-order natural frequencies in the horizontal directions of the targeted steel tower can be obtained. From Figure 3(a), in the x-direction, the horizontal natural frequency can be observed at 1.66 Hz, and from (b), in the y-direction, at 1.59 Hz. Also, no change was observed during the nine months when the measurements were conducted. From (c), the natural frequency in the vertical direction (z-direction) can be observed at 42.5 Hz. Natural frequency is the inherent resonant frequency of a structure. It varies depending on the shape, restraint position, and Young's modulus and density of the material. At this frequency, once

an external force is applied, the structure resonates and continues to vibrate on its own without the application of an external force. Natural frequency is determined by the mass and stiffness of the structure, so if the structure is damaged, its stiffness decreases and the natural frequency decreases.

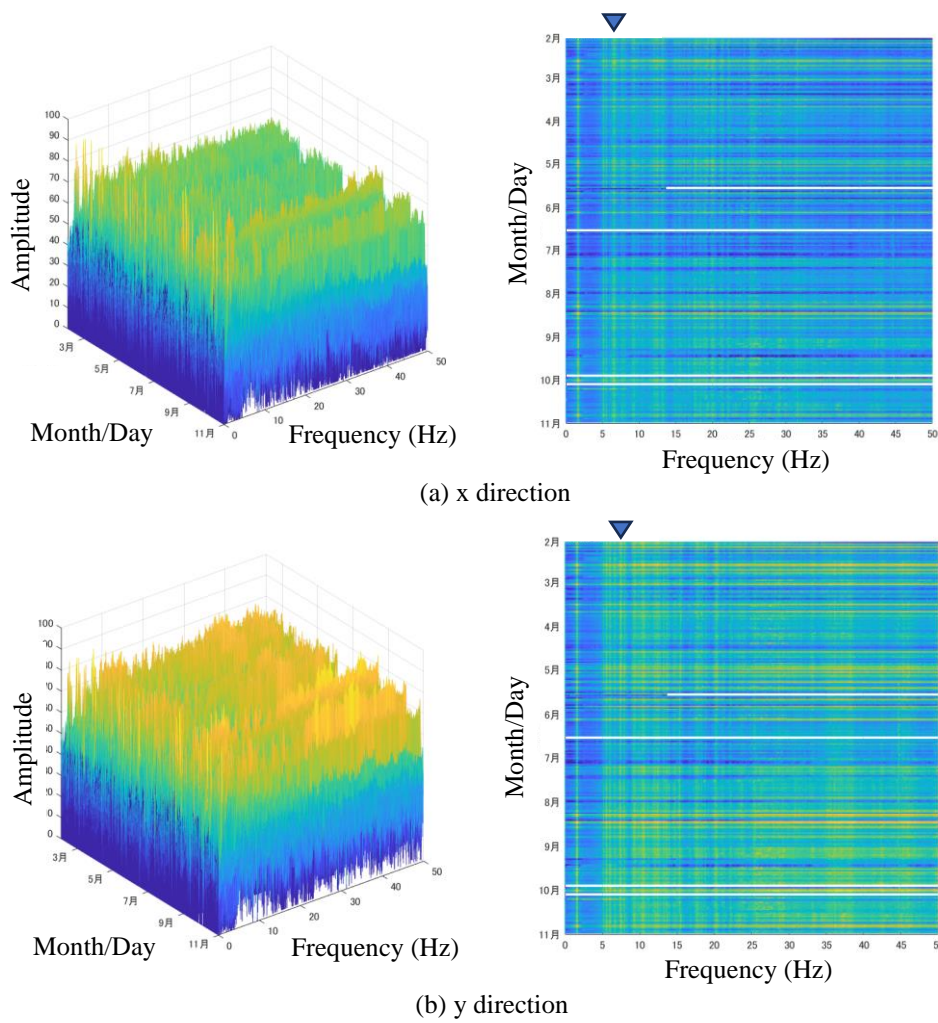
Figure 4. Fourier spectra of measured data at the top of the tower obtained by accelerometer during the measurement period.

Figure 4 shows the Fourier spectra of the measured data obtained at the center of the tower by the accelerometer during the measurement period. Since it is the acceleration at the center, the second-order natural frequencies in the horizontal direction of the targeted steel tower can be obtained. From Figures 4(a) and (b), the dominant frequency is around 6.5 Hz in both the x- and y-directions, but there is no clear peak. It can also be seen that there was no change during the nine months in which the measurements were conducted.

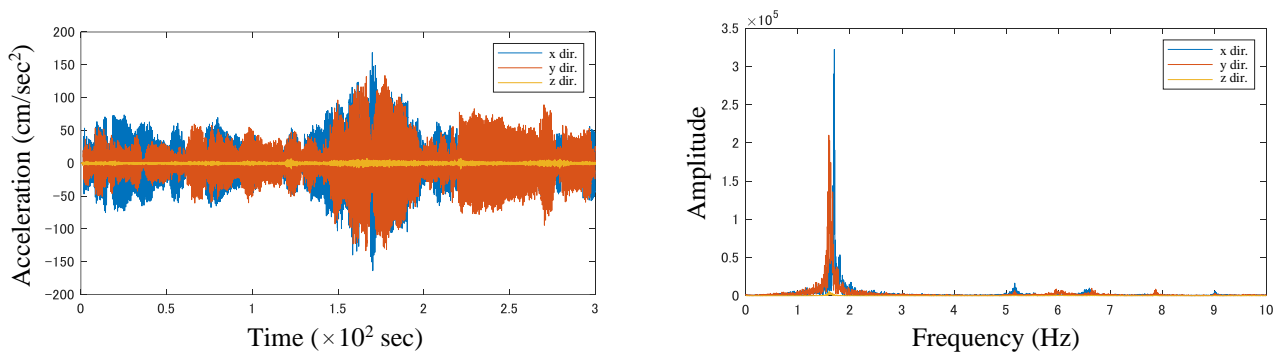
Figure 5. Fourier spectra of measured data at the top of the tower obtained by accelerometer during the measurement period.

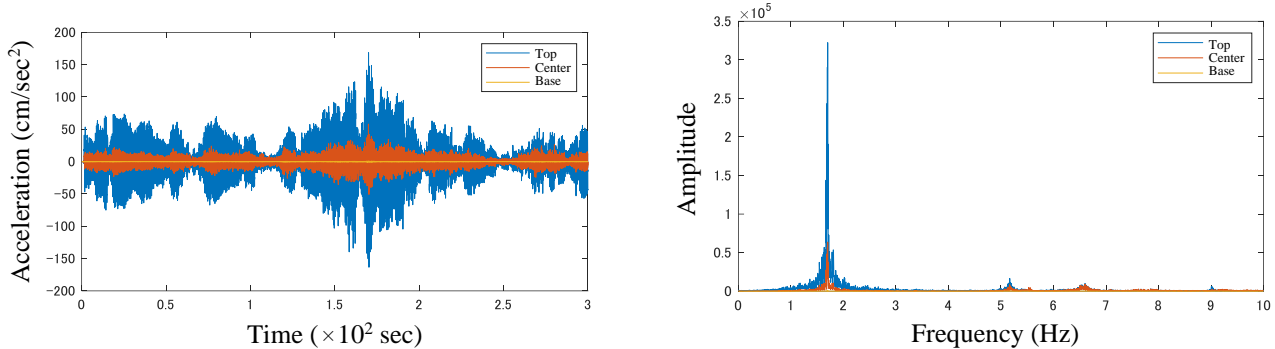
Figure 6. Fourier spectra of measured data at the top of the tower obtained by accelerometer during the measurement period (x direction).

Figures 6 and 7 show the time history waveforms and Fourier spectra of the measured data in each direction by the accelerometers on the day when the maximum acceleration of the measurement period occurred. In both the x-direction shown in Figure 6 and the y-direction shown in Figure 7, the base of tower does not vibrate, and the acceleration increases towards the center and the top of the tower, indicating the first-order mode vibrations are dominant, while the higher-order mode vibrations are small. Therefore, the first-order natural frequencies in two horizontal directions are appropriate as a risk indicator for detecting deterioration and damage to steel towers. If there is a change in the risk index, specifically if a trend toward a decrease in the natural frequency is observed, it can be assumed that the stiffness of the structure has decreased, which will lead to an increased priority for detailed inspections and planned reconstruction work.

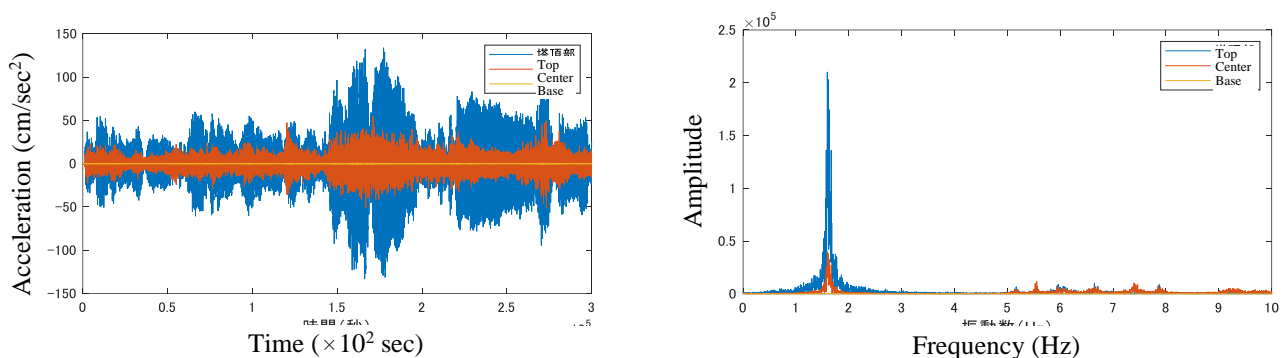
Figure 7. Fourier spectra of measured data at the top of the tower obtained by accelerometer during the measurement period (y direction).
