Virtual Reality Technology Applied in Maintaining Interior Walls Painted Buildings

Alcnia Z. Sampaio, Daniel P. Rosrio

Dep. Civil Engineering and Architecture

Technical University of Lisbon

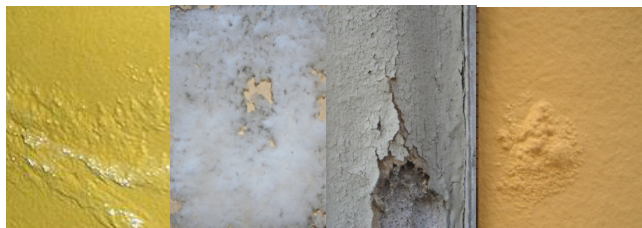
Figure 1. Swelling, efflorescence, cracking and blistering [17].

[16]. When their influence is not counteracted or minimised, imperfections can arise in the coating film, such as, the appearance of defects in the layer or paint with the loss of functionality where the desired aim of the application is concerned. These irregularities manifest themselves in various ways and in different degrees of severity. Based on the study made of the causes of the defects, specific methodologies for their resolution were established. Figure 1 shows common defects in painted interior walls.

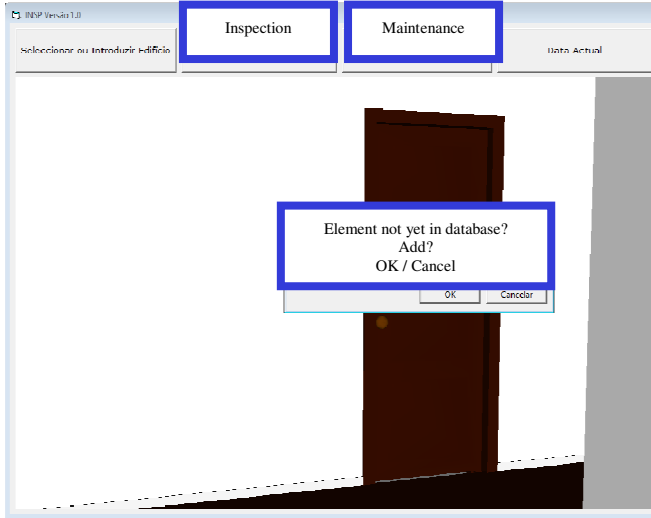
Figure 2. The main interface of the virtual application.

The main interface gives access to the virtual model of the building and to the inspection and maintenance modules (highlighted in Figure 2). The first step is to make a detailed description of the building (location, year of construction, type of structure, etc.; see Figure 3) and representative modelled elements of the interior wall coating, so that they

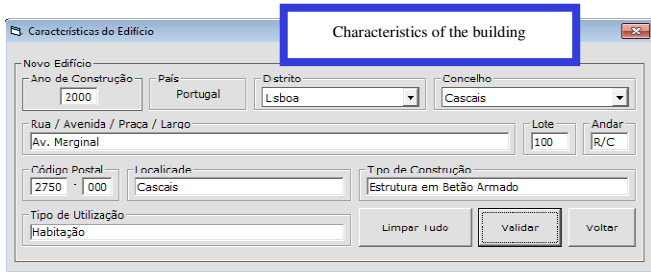
Figure 3. Interface for the detailed description of the building.

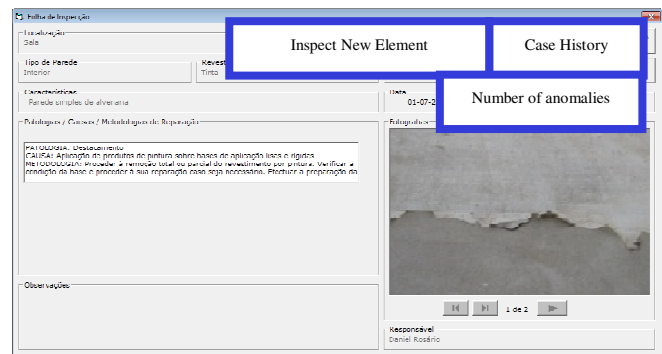
Figure 6. Presentation of the information introduced into the inspection sheet.

Later, on an on-site inspection visit, the element to be analysed it selected interactively on the virtual model. The inspection sheet (Figure 6) is accessed by using the Inspection button which is found in the main interface (Figure 2). The data which identify the selected element are transferred to the initial data boxes on the displayed page (Figure 6).

Next, using the database, the irregularity which corresponds to the observed defect, with its probable cause (ageing) and the prescribed repair methodology (removal and repainting) is selected (see highlighted area, Figure 7). The current size of the pathology should also be indicated since it reveals how serious it is (*area of pathology*, Figure 7). In the field *Observations*, the inspector can add any relevant comment (Figure 6), photographs obtained on site can also

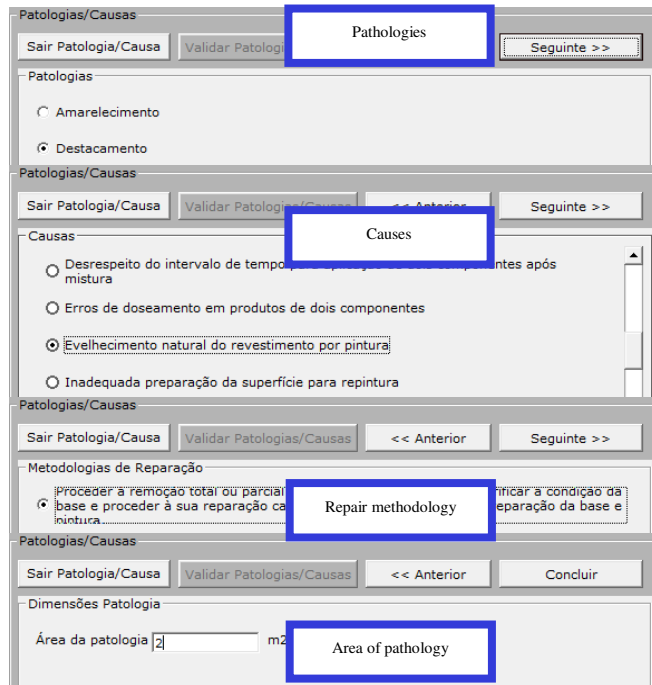
Figure 7. Interface for the selection of the irregularity, probable cause, area and repair methodology.

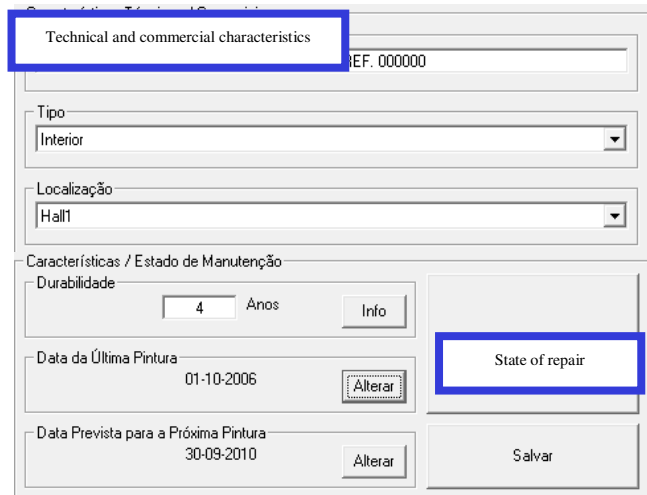
Figure 9. Technical characteristics and the durability of the paint-work.

Based on these data, it is possible to link in the date the virtual model is consulted and visualise, in the geometric model, the level of wear and tear as a function of time (see *state of repair*, Figure 9).
